# Manhole Inspection Summary

Manhole # S29CC\_006MH

Insp Date: 1/11/07 2:57 PM

**Location** Address: **1100 DOLPHIN ST**

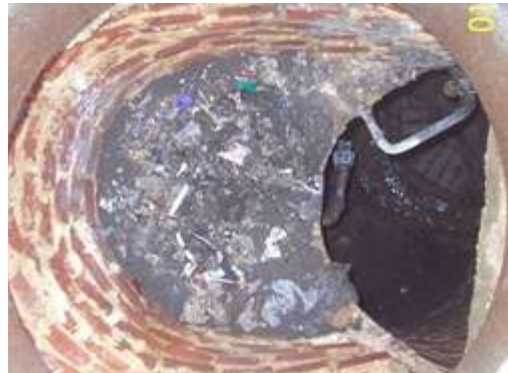
Top View

Corroded steps. Evidence of surcharge - Bench debris.

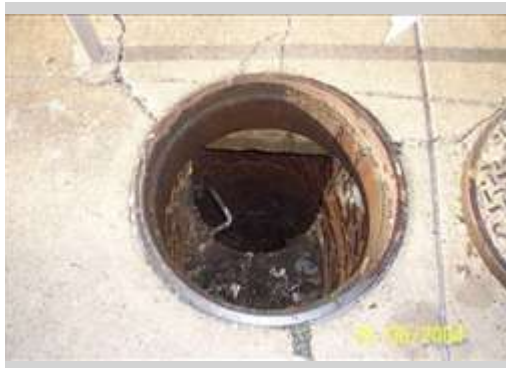
Defect

☒ **Leaks**

Infiltration: ☐ None ☒ **Joint** ☐ Cracks ☐ Mortar ☐ Roots ☐ Wall

Frame leaks. Adjustment infiltration.

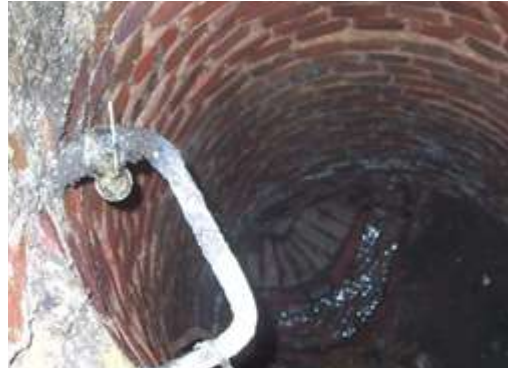
Defect

Infiltration: ☐ None ☐ Joint ☐ Cracks ☒ **Mortar** ☐ Roots ☒ **Wall**

Adjustment, Corbel and Barrel infiltration.

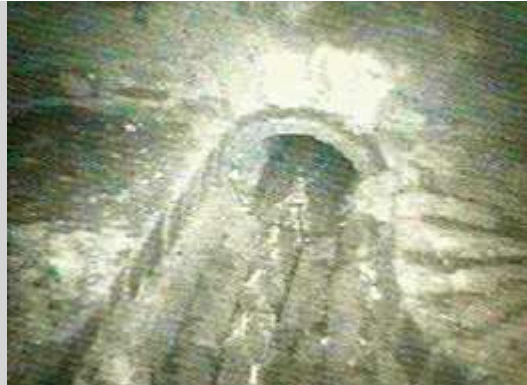
### 8 in. Circular Gravity Sewer Pipe Out @ 12 O'Clock

Infiltration: **Evidence** Pipe Seal Cond: **Unknown**

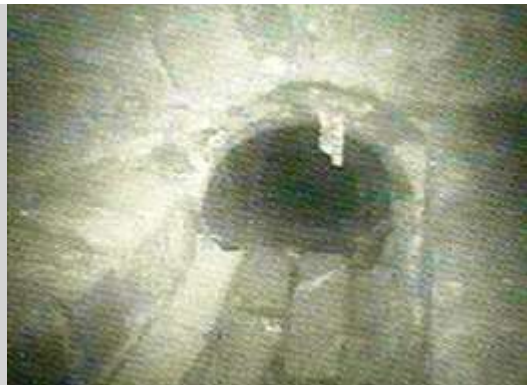
### 8 in. Circular Gravity Sewer Pipe In @ 3 O'Clock

Infiltration: **Evidence** Pipe Seal Cond: **Unknown**
